Door ID 0015487
Description PUR 16'6" w x 16'6" h HST

Door Notes	Door #3. Main shipping door.
------------	------------------------------

Door - PM Report

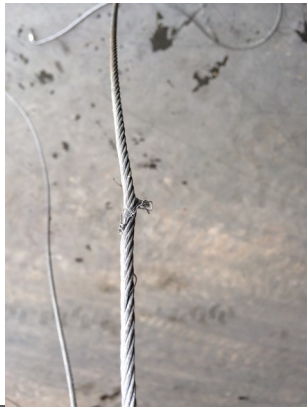
0015487 Cables, cable anchors, bottom brackets	0015487 Bearings, bearing plates

GRADE	INSPECTION ELEMENT	NOTES	PHOTO
Fail	Cables, cable anchors, bottom brackets	[2014-03-09 19:39] FW: Cables frayed LH. Both should be replaced.	Yes
Pass	Rollers, roller brackets, end framing, center hinges	[2014-03-09 19:42] CW: Replaced 6—3" long stem rollers.	
Pass	Struts, span braces		
Pass	Vertical track, brackets		
Pass	Sections, joints, gaskets	[2014-03-09 19:49] FW: Cosmetic damage on 3rd section.	
Pass	Windows, glazing		
Pass	Shaft, coupler, drums		
Fail	Bearings, bearing plates	[2014-03-09 19:52] FW: Bearing and bearing plate damaged LH.	Yes
Pass	Torsion springs		
Pass	Door level, balance	[2014-03-09 20:05] CW: Door was heavy. Rebalanced.	
Pass	Horizontal track		
Pass	Pusher springs, bumpers, stops		
Pass	Back-hanging		
Pass	Door safety labeling	[2014-03-09 19:54] CW: Applied safety labels—bottom brackets, eye-level and torsion ass'y tag.	
Pass	Weatherstrip, U-rubber, top flap		
Pass	Track guards
